# **Flooding and Stormwater Management Plan for Ambler Area Watersheds**

© Center for Sustainable Communities  
Temple University Ambler  
December 2014

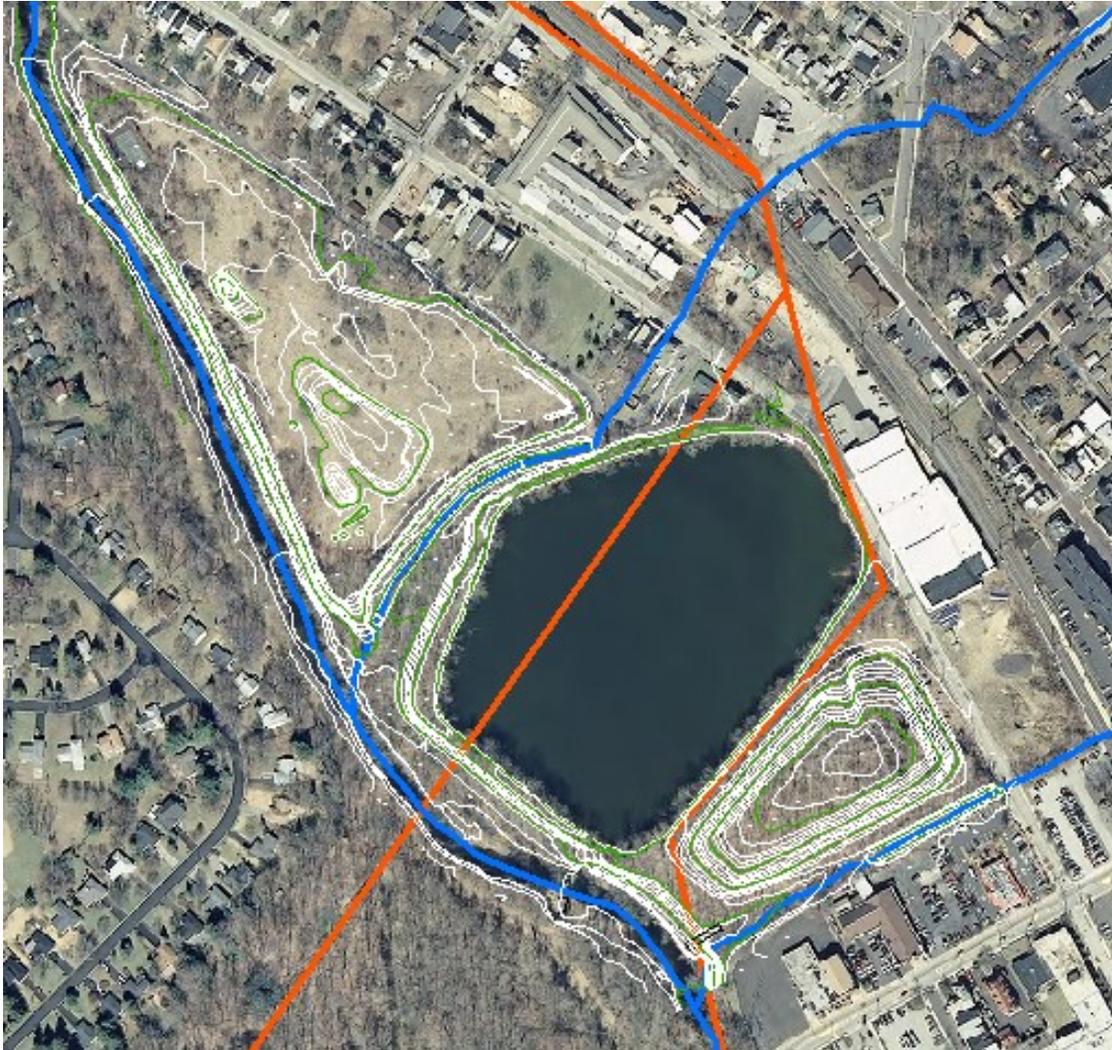
**Figure 7:** LiDAR data was checked against imagery based elevation data from Aero 2 in selected areas such as the asbestos site

The CSC project team found some problems with the PAMAP LiDAR data in the study area. These included inaccurate TIN and contours, and missing break lines. BAE Systems Inc. was hired to fix these problems. BAE provided improved contour definition at streams, improved break lines with elevations of streets and a few headwalls, and an enhanced merged TIN data that proved crucial to the hydraulic modeling. BAE Systems processed the existing (4) 10K x 10K PAMAP LiDAR tiles by hydro-enforcing break lines for single line drains for 3.93 square miles covering the study area and provided PAMAP specification deliverables of this data. Per tile deliverables included:

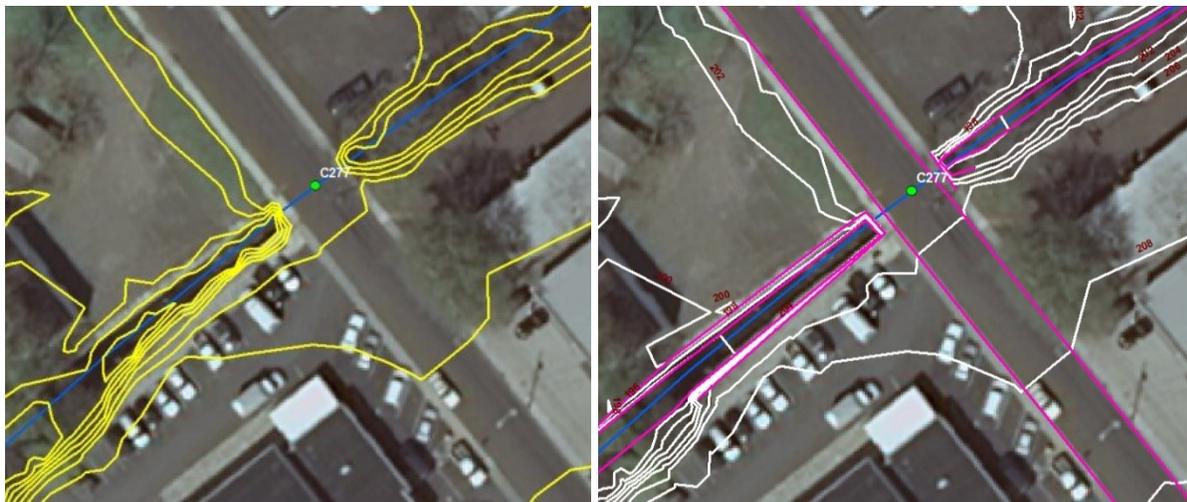
**Figure 9:** BAE Systems refined contours and added break lines for streams and roadways.

Break lines were provided as shapefiles (a GIS file format) so elevations could be read more easily in ArcGIS software. Figure 8 shows examples of the work done by BAE Systems.

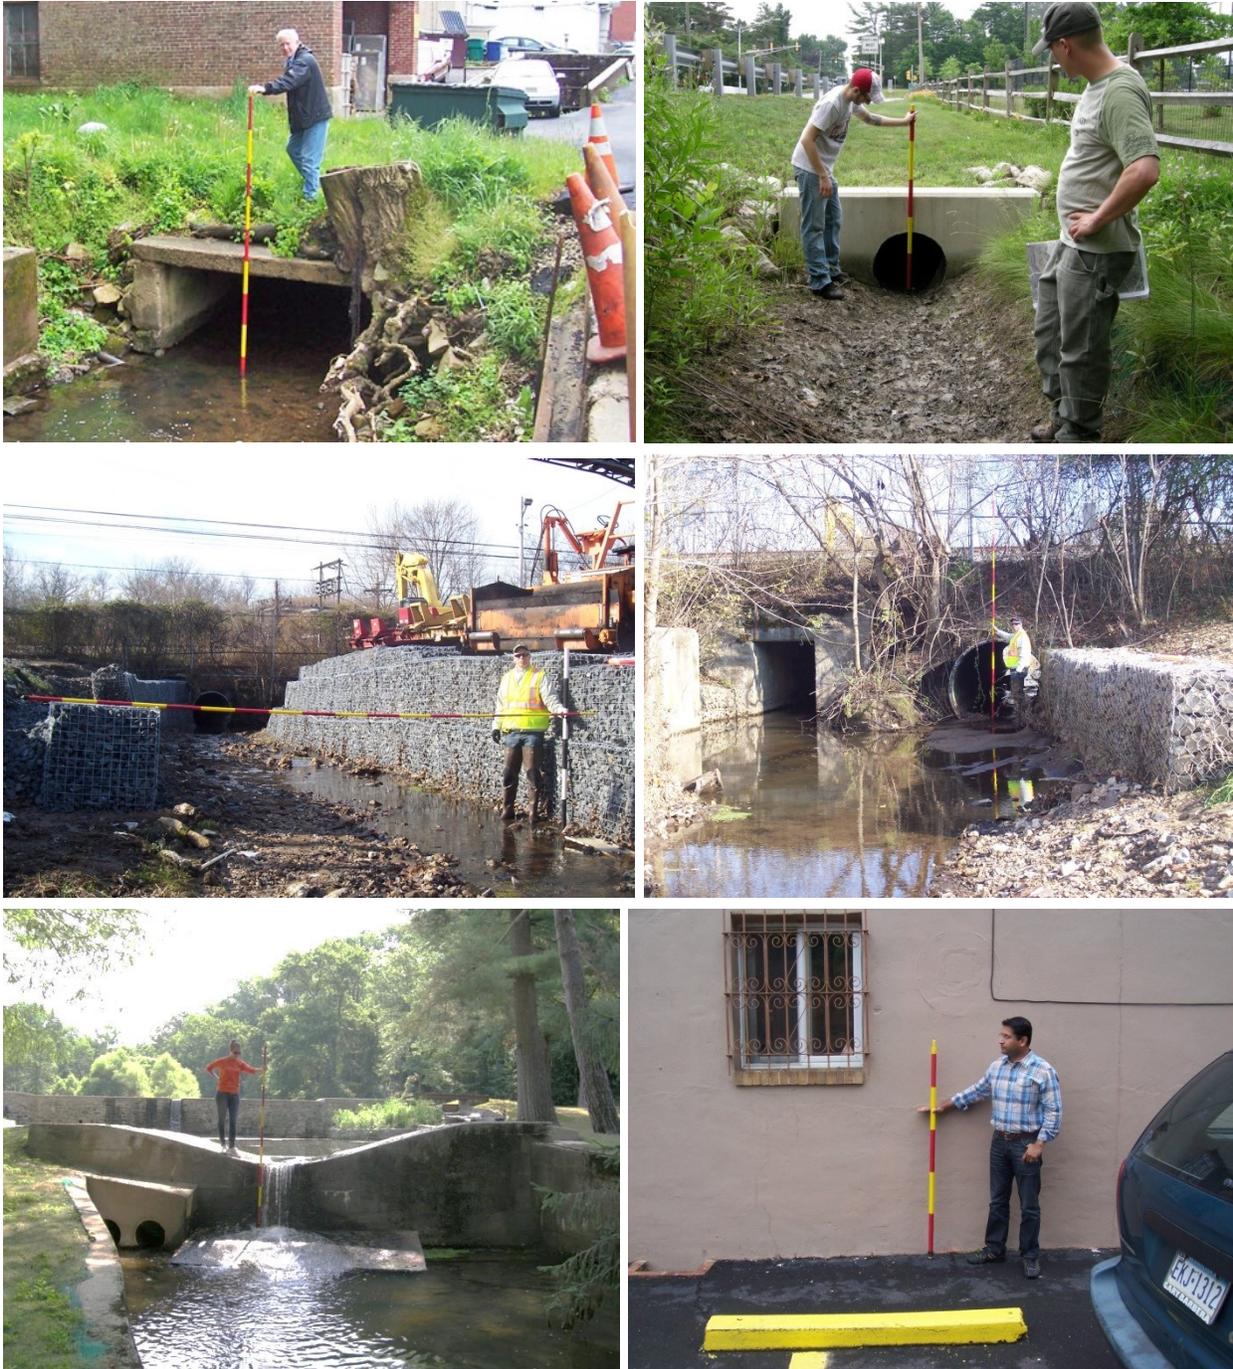
**Figure 11:** A collage of photographs measuring obstructions and high water marks in Rose Valley Creek, Tannery Run, and Honey Run/ Stuart Farm Creek

Obstructions field data were collected by the project team from 2009 to 2012. Data included (i) photos with 1 ft. Philadelphia Rod; (ii) dimensions; (iii) channel conditions; and (iv) reference to road or headwall. Obstructions to flow were measured for current dimensions. Figure 11 shows a collage of pictures from field surveys. As shown in Figure 12, 94 sites, including bridges (n = 16), culverts (n = 63), and dams (n = 15), were inspected and photographed. High water marks were checked. Sketches were prepared for entering obstruction data. See Figure 13 for an overview of the work-flow.

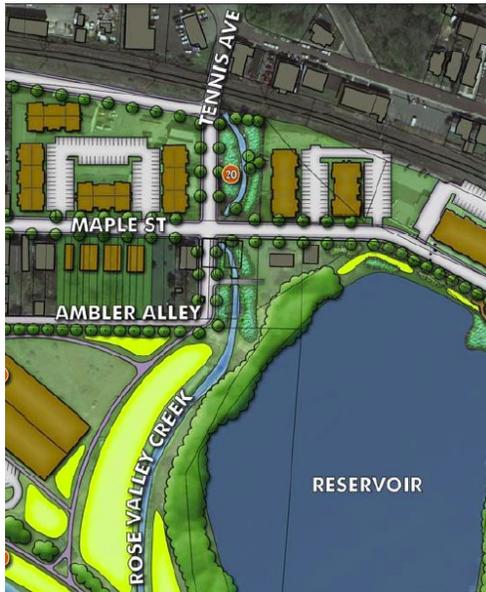
**Figure 14:** Concept Plan showing channelization of Rose Valley Creek<sup>12</sup>

This neighborhood revitalization plan has proposed channelization (or day-lighting) of the Rose Valley Creek, as shown in Figure 14 – location 20.

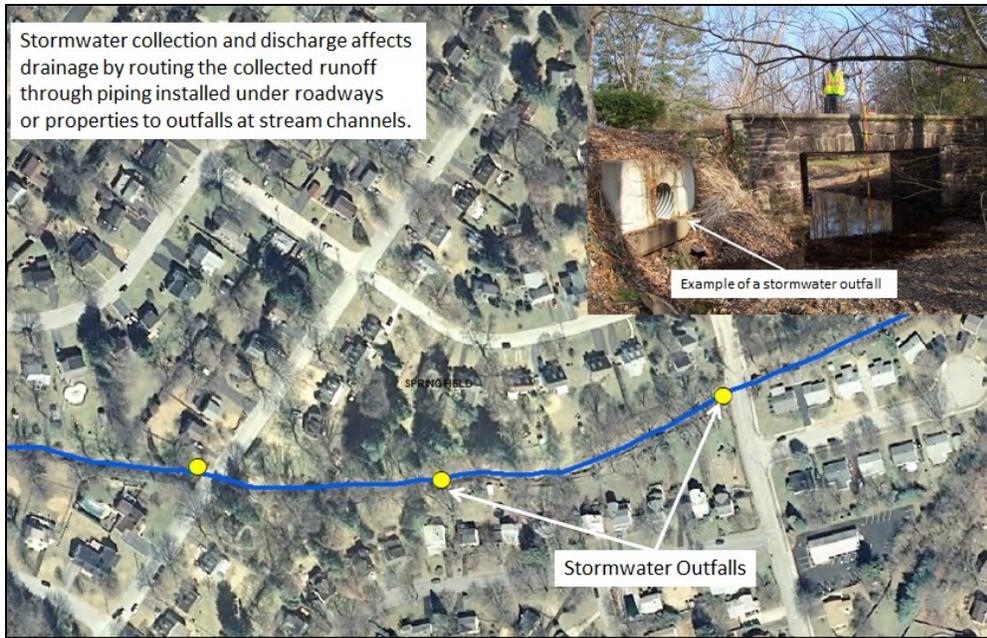
Figure 25: Stormwater collection and outfalls

The single largest land use category in the watershed is single-family residential. In most residential areas, only a portion of the water falling on roofs and properties enters the street, and subsequently the storm inlets, depending on the slope of the property and gutter drainage onto the property. The remainder of roof and property drainage infiltrates into the soil, and as the soil becomes saturated, runoff flows at an increasing rate to the street or to other drainage basins offsite. As housing density increases, a larger proportion of each property’s drainage enters storm inlets. In the most developed sections of the watershed with curbed roadways, the roadways channel runoff to the storm inlets during smaller storm events, and become stormwater channels once runoff exceeds the capacity of the inlets and/or pipe capacities. Development alters the local runoff pathway, particularly for smaller storms, and the runoff to stream channels is often controlled by the location of stormwater inlets, piping, detention basins, and outfalls. This situation is depicted in Figure 25. The watershed boundaries and outfall locations were used as guidance in delineating subareas for modeling. A map showing outfall locations in the watershed is shown in Figure 26. In addition, an example of a municipal stormwater system map, with stormwater piping, inlet and outlet locations provided by Upper Dublin Township, is shown in Figure 27.

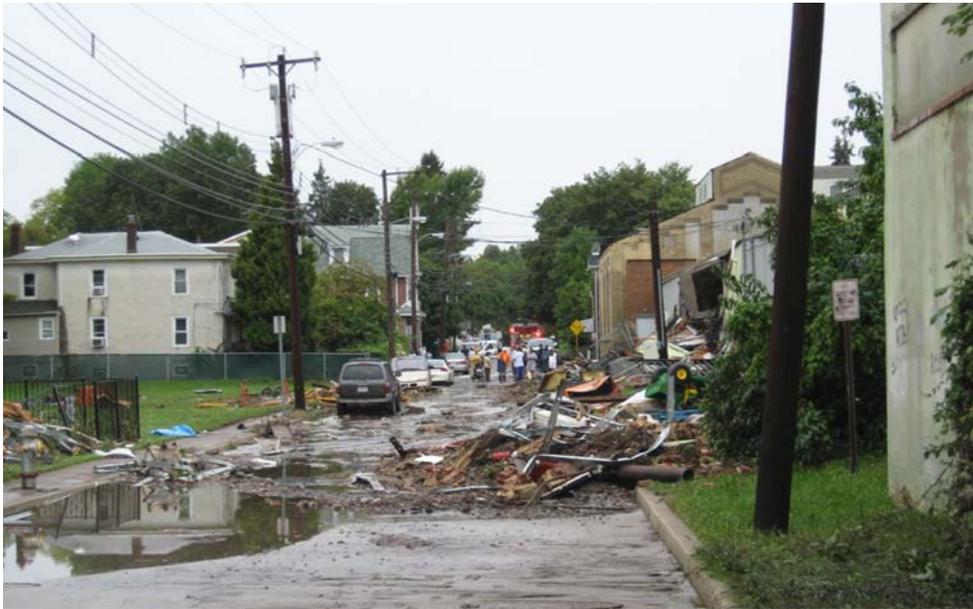
**Figure 29:** West Ambler neighborhood after a flooding event. This area is not within existing FEMA floodplain boundaries.

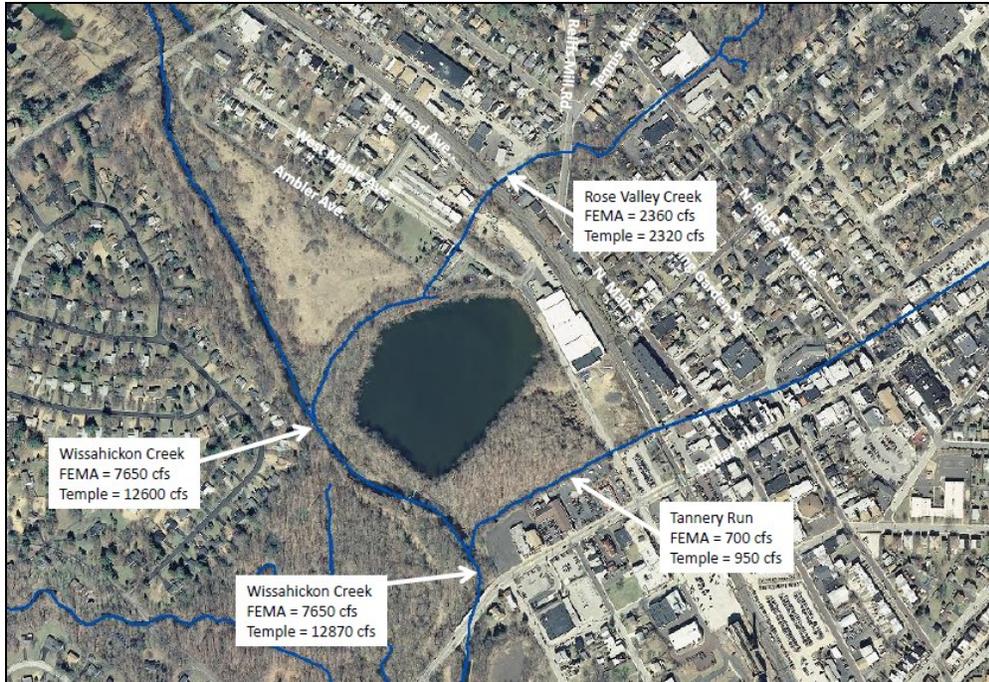
**Figure 38:** Q100 Peak Discharge Comparison – Temple Values vs. FEMA Values

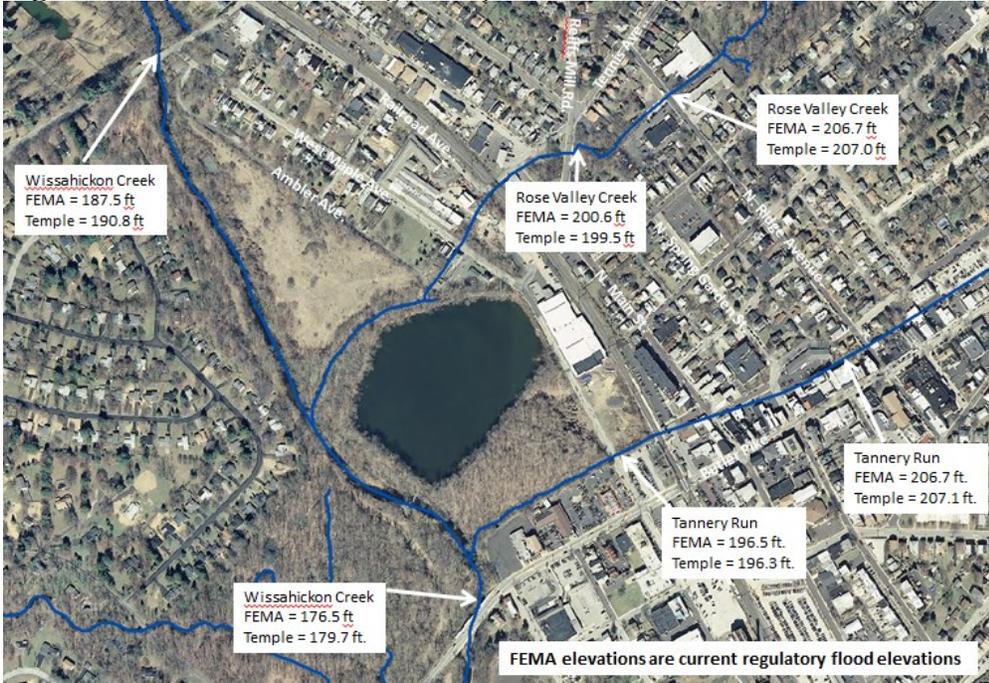
**Figure 39:** Q100 elevation comparison for Wissahickon Creek, Rose Valley Creek and Tannery Run

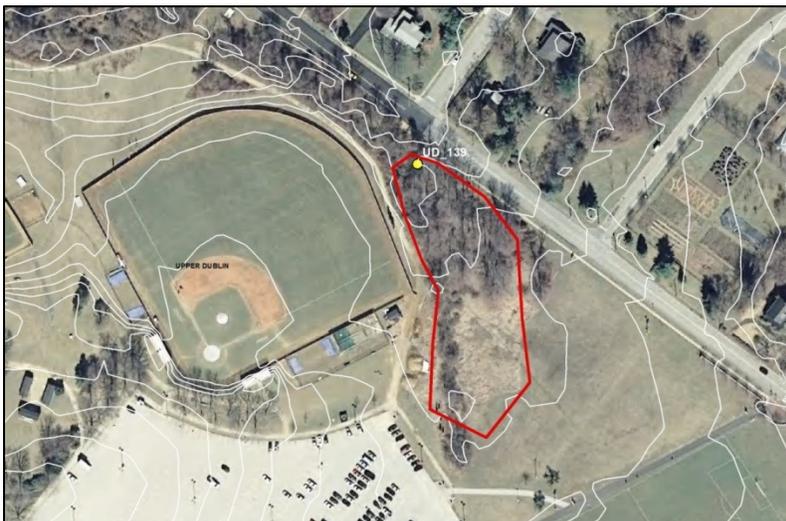
**Figure 49:** Sample detention basin site map. Site UD\_139 – Potential extended detention/constructed wetland in Upper Dublin Township on Temple University campus between baseball field and Susquehanna Road. Potential new storage = 3.2 acre-ft and estimated cost = \$320,000.

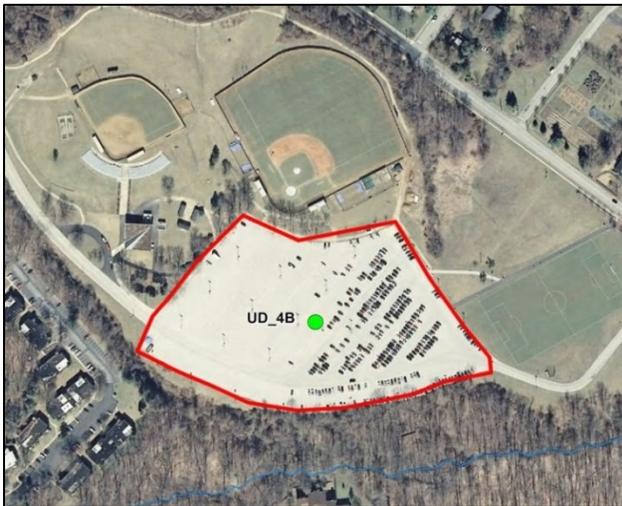
**Figure 50:** Sample Infiltration Site. Site UD\_4B – Potential infiltration site in Upper Dublin Township, student parking lot on Temple University campus. Potential new storage = 0.67 acre-ft, estimated cost = \$128,000.

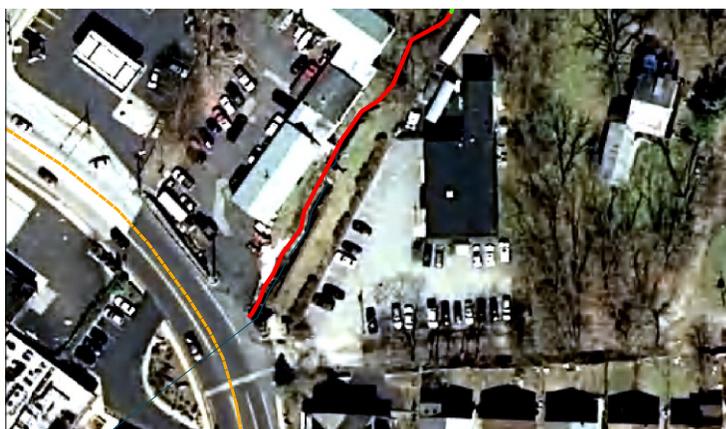
**Figure 51:** Sample riparian buffer restoration site, Tannery Run, Upper Dublin Township

potential additional storage available, the study team assumed an average buffer width of 75 feet for each side of the stream and an average runoff volume reduction of one inch. The estimated acreage and cost of re-establishing the buffers by municipality is presented in Table 14. The total additional storage volume provided to the study area would be **2.84 acre-ft**. Riparian buffer restoration has the lowest average cost of the three improvement categories. It should be noted however, that actual buffer width would vary significantly from site to site, and buffers may no longer be feasible at some locations. The lack of acceptance by property owners can also limit re-establishing buffers. A GIS file for the infiltration sites can be provided upon request. A sample site map is shown in Figure 51. For more detailed information on specific riparian buffer sites, see Appendix D.

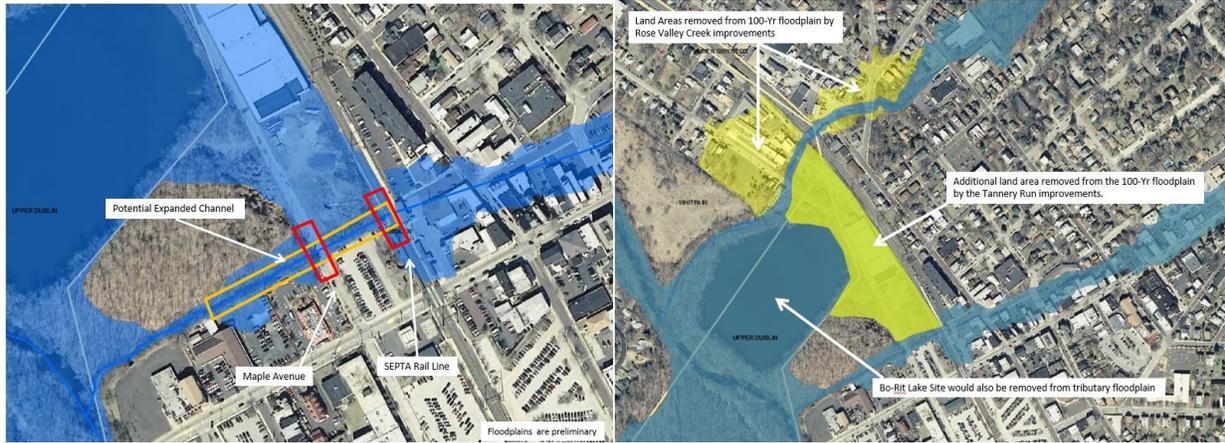
**Figure 57** (a and b): Enlargement of Tannery Run Channel combined with construction of new bridge spans for Maple Avenue and the SEPTA rail line (left); Area removed from floodplains after Tannery Run and Rose Valley Creek structural improvements are made (right)

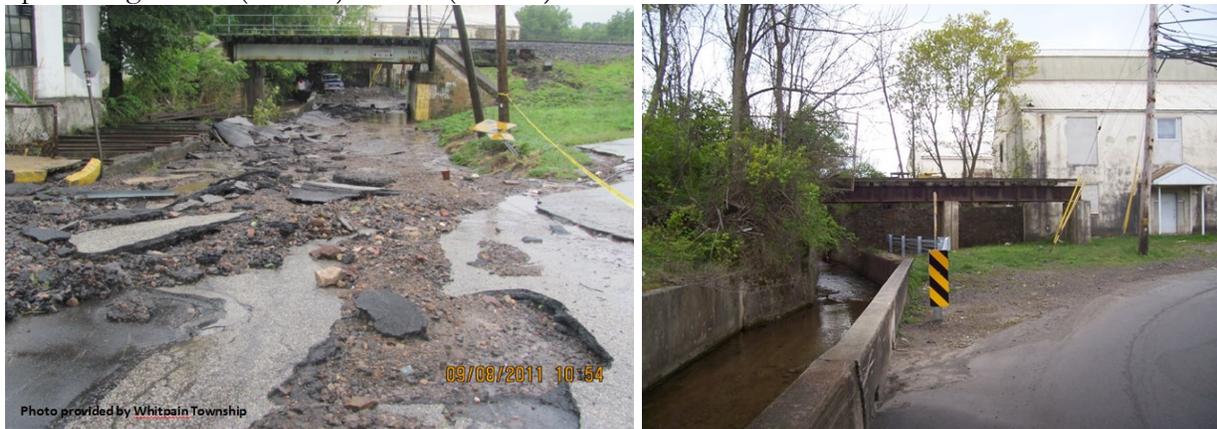
**Figure 58** (a and b): Channel could begin on downstream side of the SEPTA Bridge

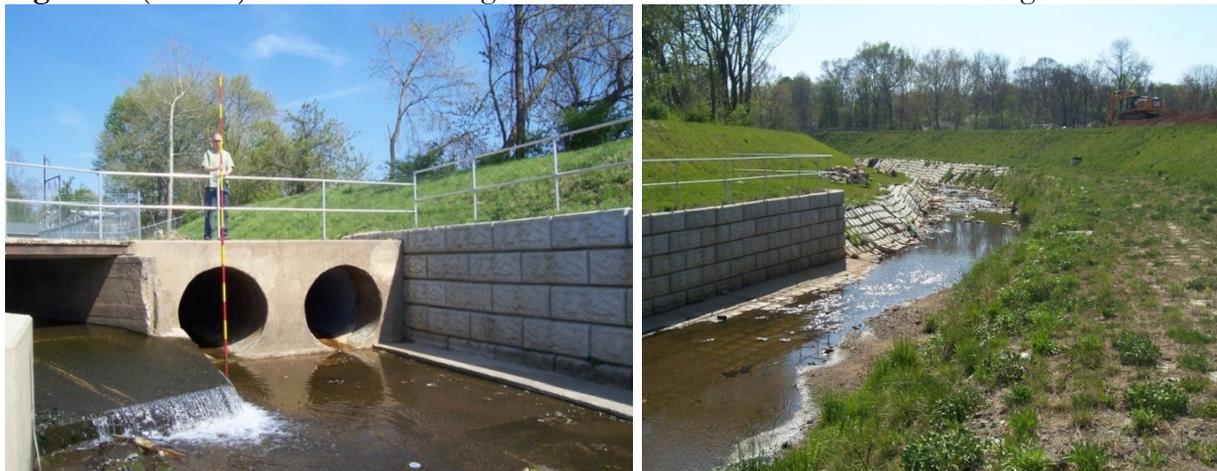
**Figure 59** (a and b): Downstream end of bypass and main channel (left); downstream channel (right). Photos were taken in March 2012.

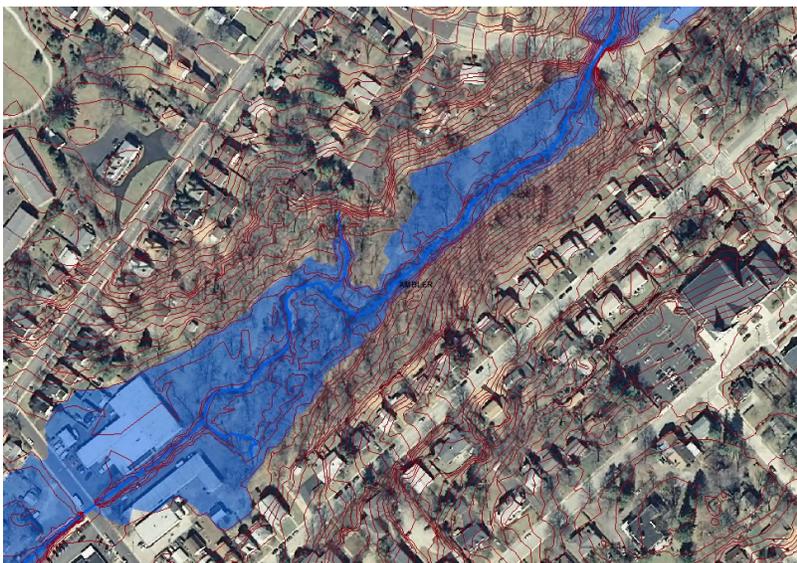
**Figure 62:** Ambler Park

For the Ambler Park site, there is a potential for additional storage. Modeling shows that the park currently stores about 12 acre-ft. of floodwater during the 100-Yr storm. Three options for specific projects include:

- Consistent with Appendix B, create two acres of additional wetland area. This would provide an additional four acre-ft. of storage.
- Excavate four acres. This would require additional tree removal and provide up to 12 acre-ft. of additional storage.
- Construct a dam in addition to option mentioned above, to provide up to 30 acre-ft. of additional storage. The dam would have to be coupled with an extended channel for Rose Valley Creek (Option 4 of Site 1) and be similar in design to the Rapp and Pine Run dams in the Sandy Run Watershed.

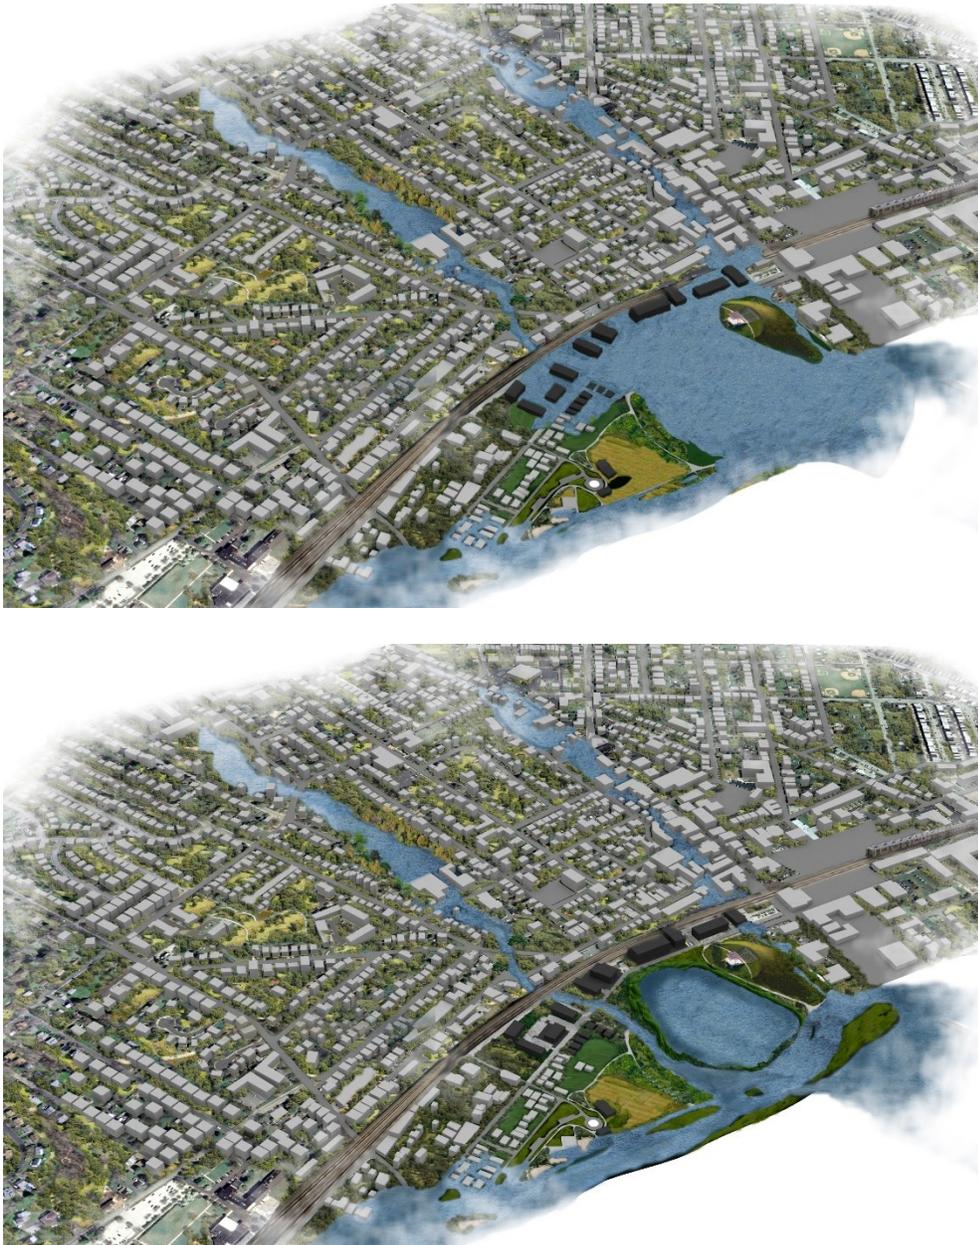
**Figure 63:** BoRIT site – before and after improvement on Rose Valley and Tannery Run
